Robertson Gymnasium Re-Roofing, Bldg. 533

Project No. FM100345S/101-78

**Addendum No. One**

<b>Tent ID:</b>	<b>University of California Santa Barbara</b>	<b>Facility ID:</b>	<b>533 Robertson Gymnasium</b>
<b>Square Feet (entire facility):</b>	<b>73,600</b>	<b>Location:</b>	<b>Ocean Road</b>
<b>Facility Contact:</b>	<b>Bob Wright</b>	<b>Contact Email:</b>	<b>robert.wright@pf.ucsb.edu</b>
<b>Contact Title:</b>	<b>Physical Plant Superintendent</b>	<b>Contact Phone:</b>	<b>805-893-2662</b>
<b>Fax Number:</b>	<b>805-671-2642</b>	<b>Last Inspection:</b>	<b>NA</b>

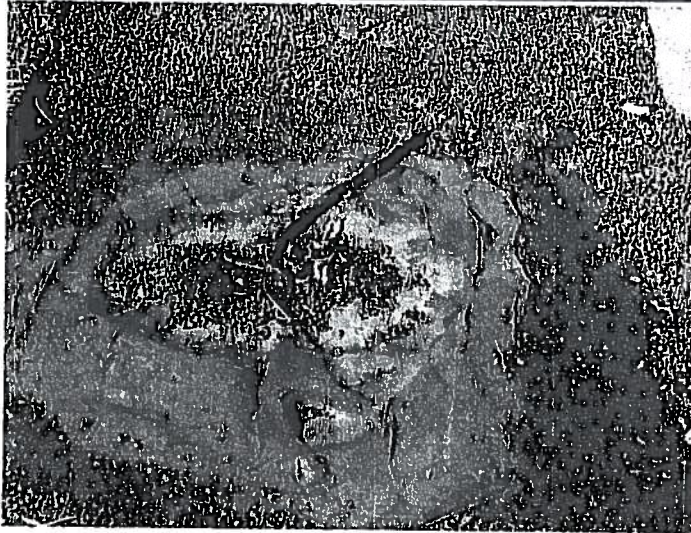
There was a large failure in the system that has been patched and still a trouble spot.

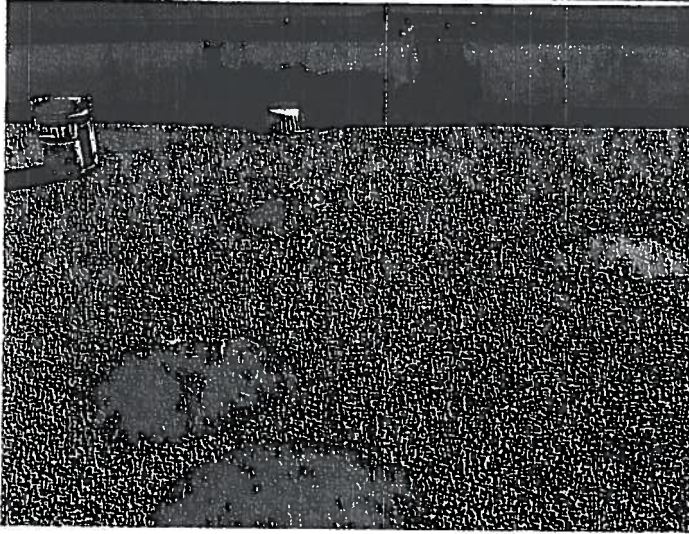
any patched in the field of the roof where blisters and seam splits occurred. A can roof mastic near the parapet wall where there are several failures in the base flashing. Once again caused by differential move as this roof system did NOT allow for movement of any kind.

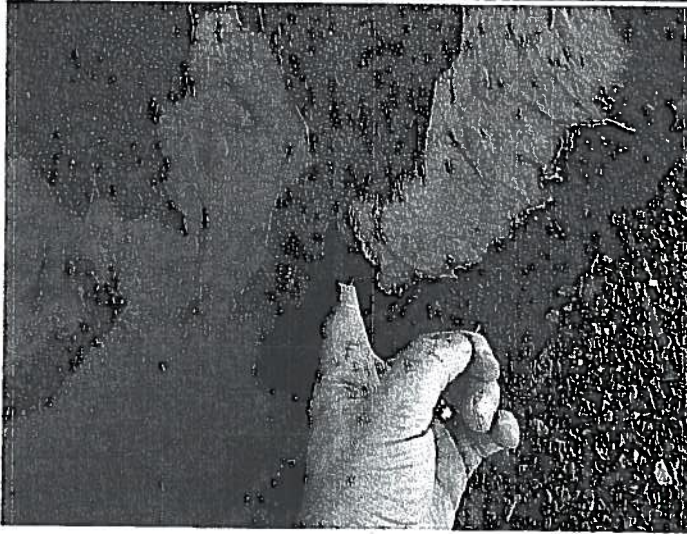
Another hole in the base flashing where many repair attempts have already been made.

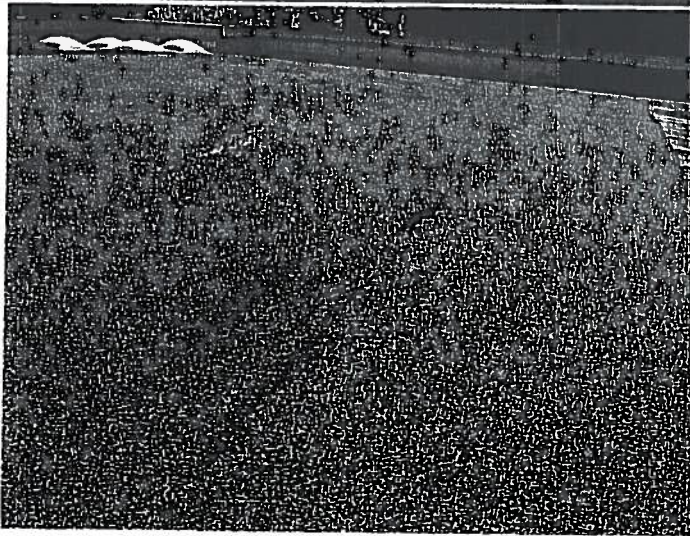
view of blisters and seam splits that are evident of a failed roof.

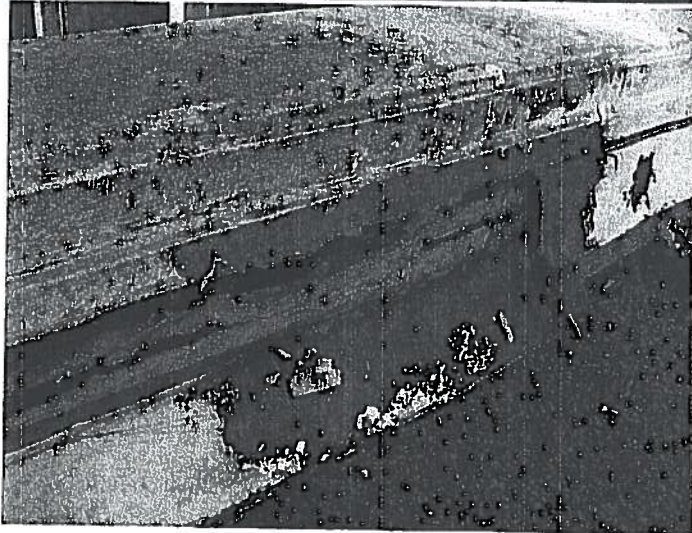
The reglet joint has failed and pulled away from the parapet wall exposing the rolled up base flashing.

Repair the failed reglet joints with Tuff Stuff, a moisture-curing, single component non-sag polyurethane sealant, to seal the gaps in the seams and reset the counter flashings..

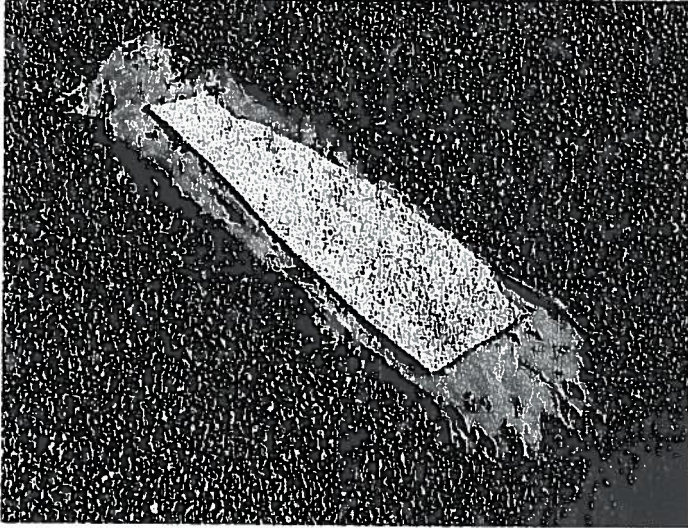
Location where there was a leak that was patched. The roofing mastic used has since dried out.

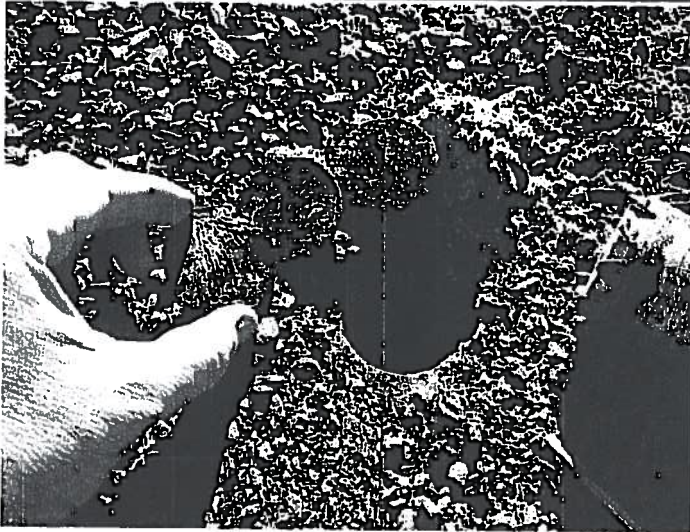
Core sample shows how badly the inter piles have dried out and pulled apart.

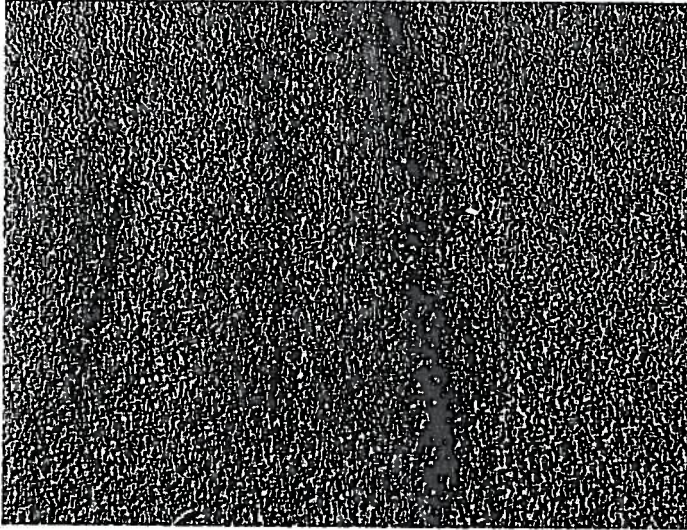
Seams splits and blisters on the roof section.

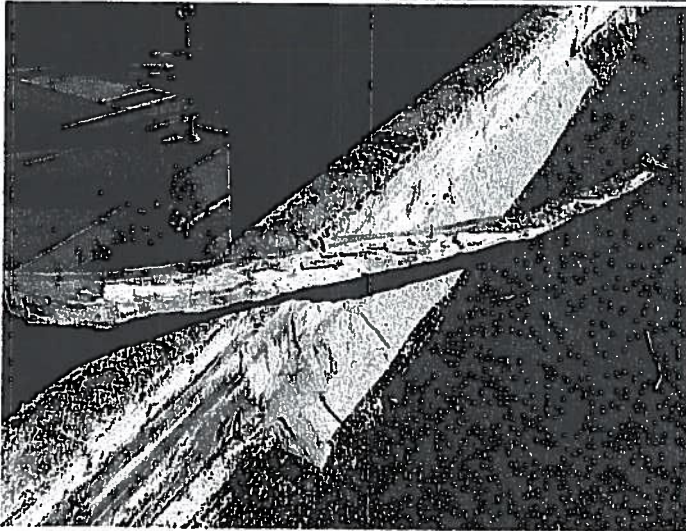
Another section where the reglet failed and the counter flashing has completely fallen off.

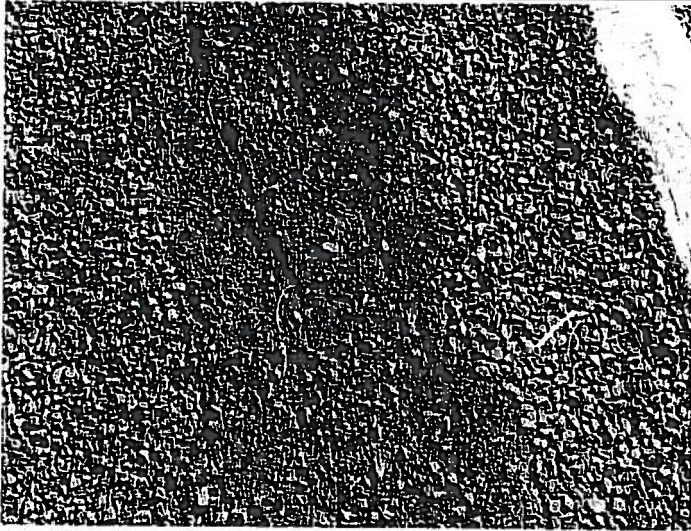
Seam split in the field near the expansion joint.

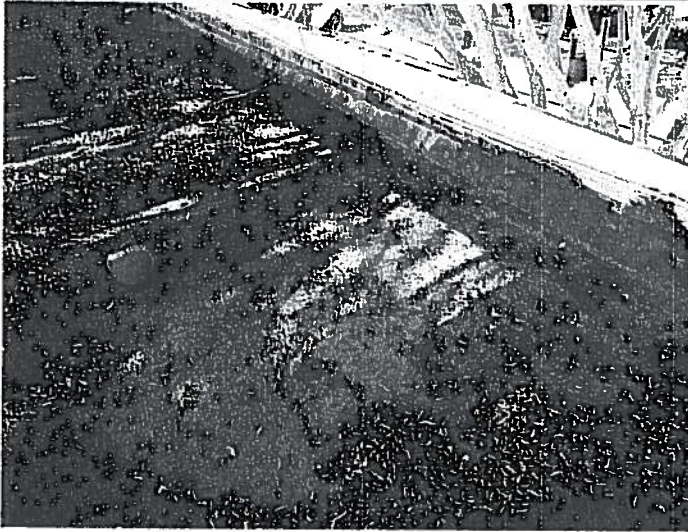
In the center of the roof section on the south side there is a large area that has been patched due to previous leaks. A large amount of debris from the nearby trees is also pictured.

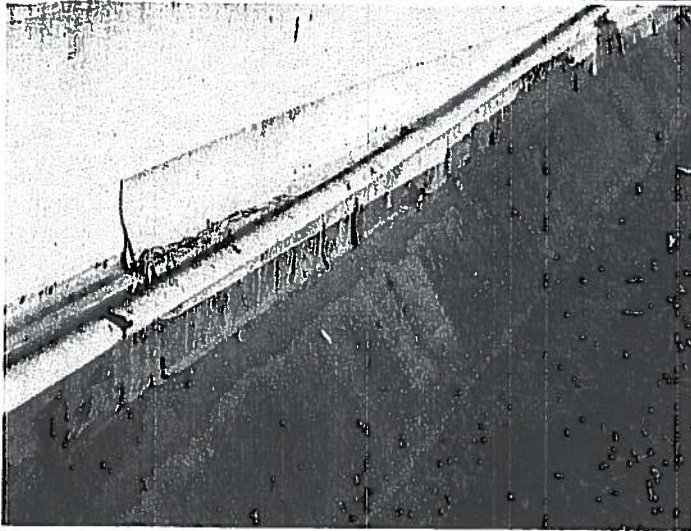
The reglet joint along this section of the parapet wall had failed and has also been patched. A lot of moisture in this area is evident as it does not get much sunlight.

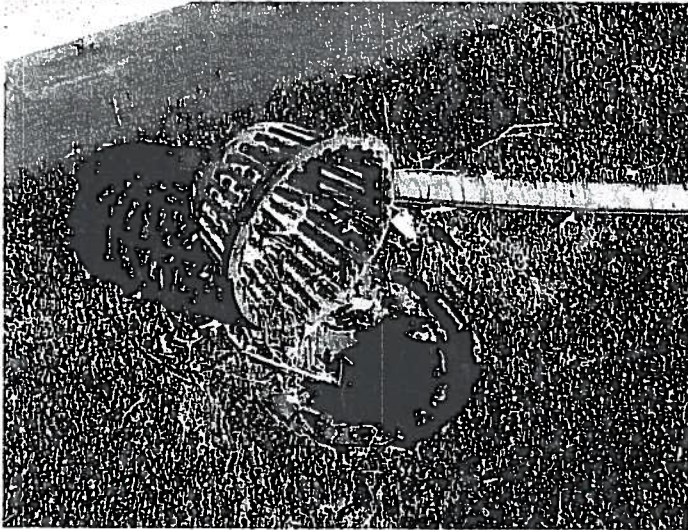
The drain cage at the north end of the roof section is not secured and repairs have been made around the ring attachment.

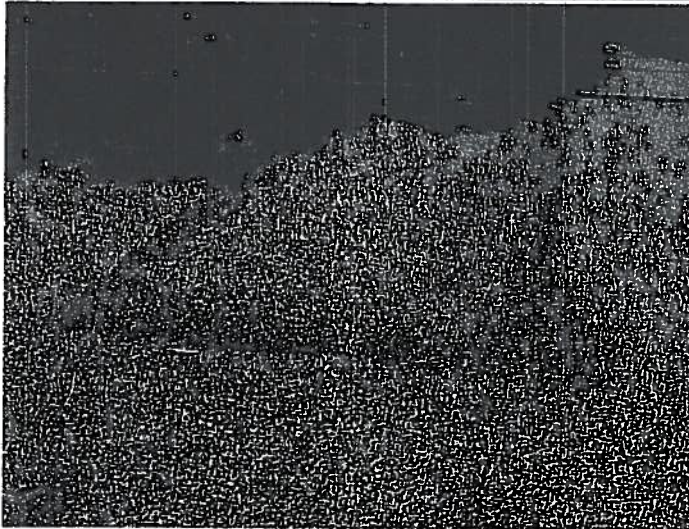
This shows seams separation in the field of the roof possibly from a poor installation of the roof. The seam splits are large enough to let moisture into the system.

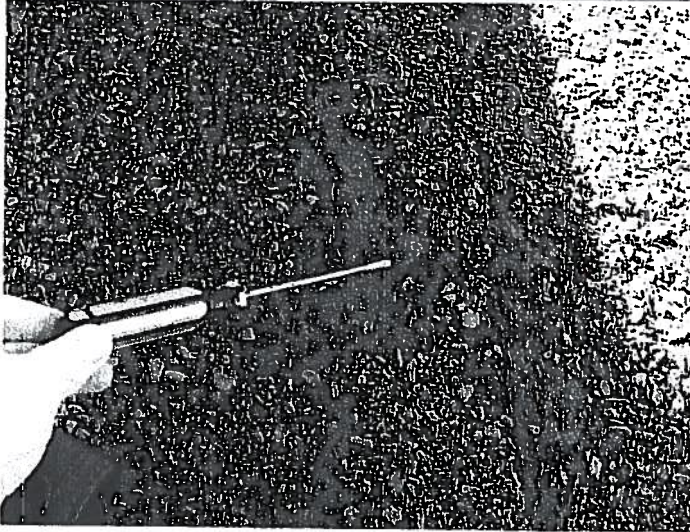
Here you can see the gravel has lost adhesion and has exposed the membrane. The membrane has dried out and become brittle.

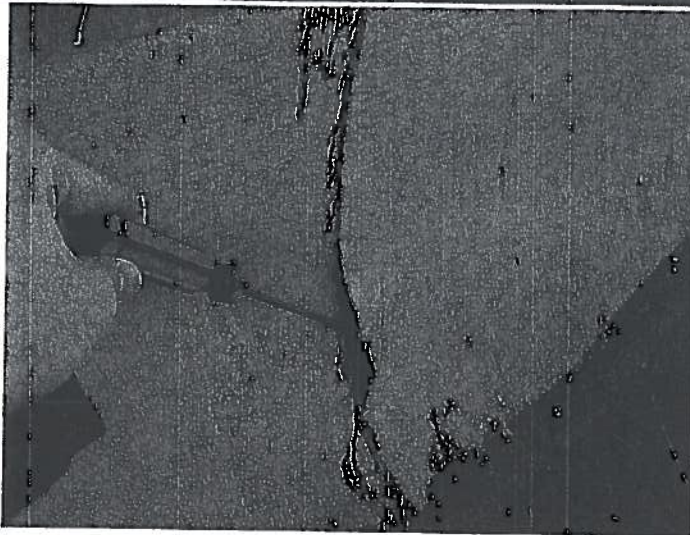
any of the base flashings seams have split just like in the example above, this is due to differential movement that occurs in this roof system.

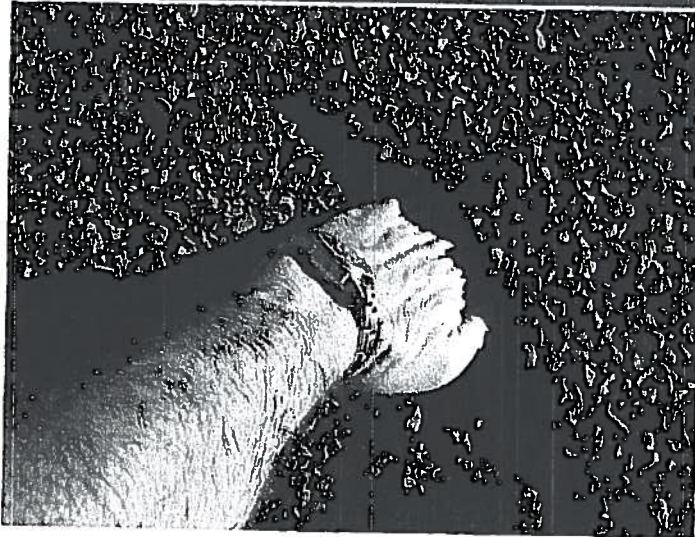
This is one of many blisters on the roof. Water has seeped into the system, has become trapped and then expanded during the day creating a large blister. This blister had "burst" and you can see the severe damage created.

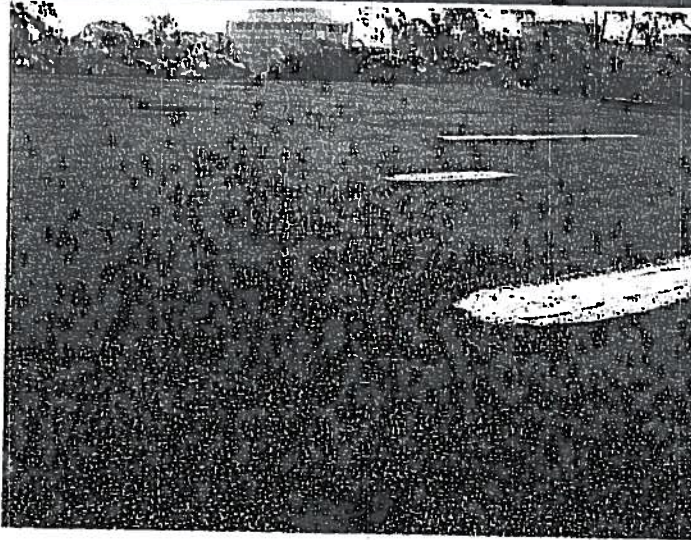
This view shows many more blisters on the roof as well as the patches that have been made to try and stop the leaks. Each silver area is a patch.

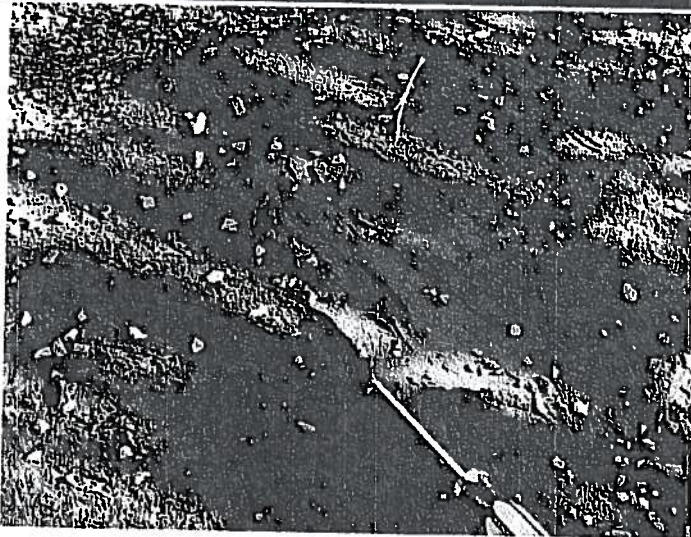
Another view of the dried roof where the inter plies are exposed showing the failure of the roof.

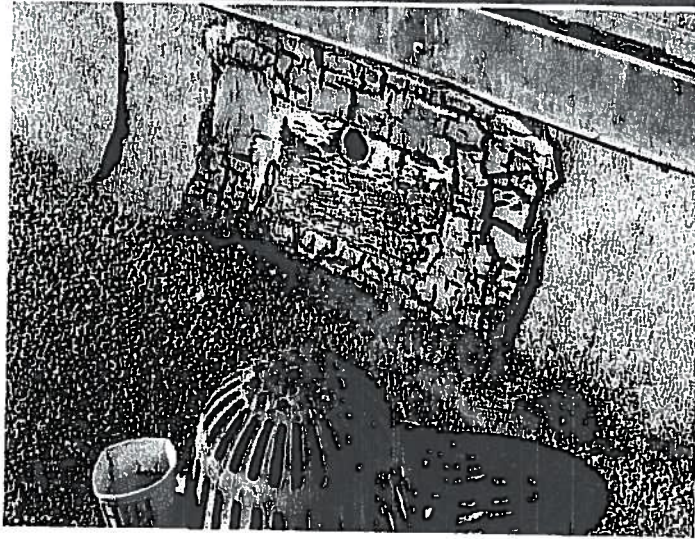
Flashing repair near a drain. There are many repairs like this along the parapet wall.

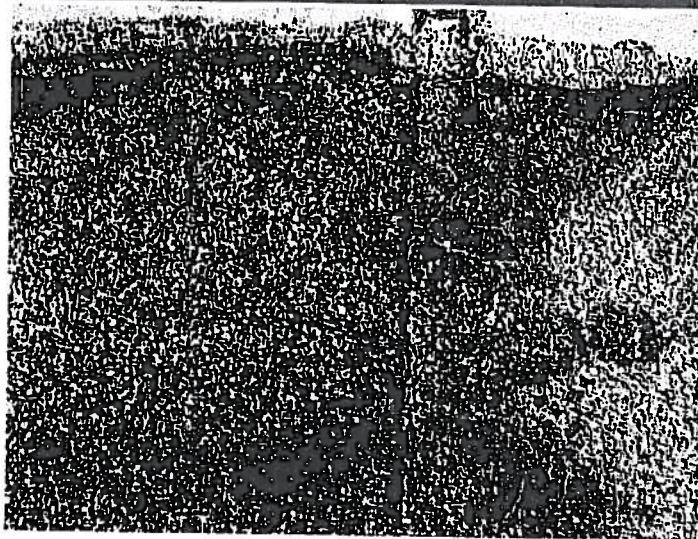
The poor gravel adhesion has caused the asphalt below to become exposed and begin to alligator.

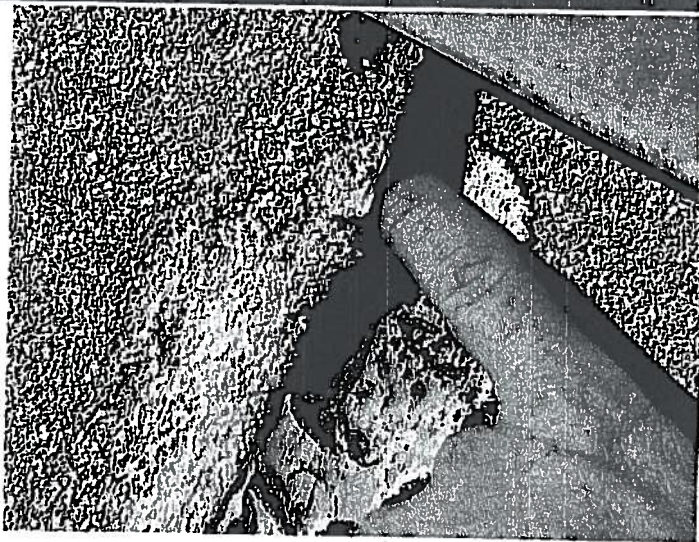
Differential movement has caused the seams to split along the parapet wall.

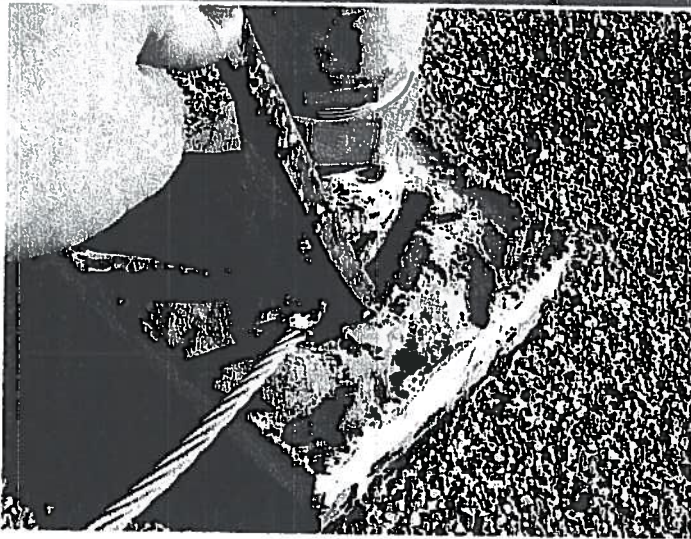
The pitch pockets on this roof section have all dried out and need attention.

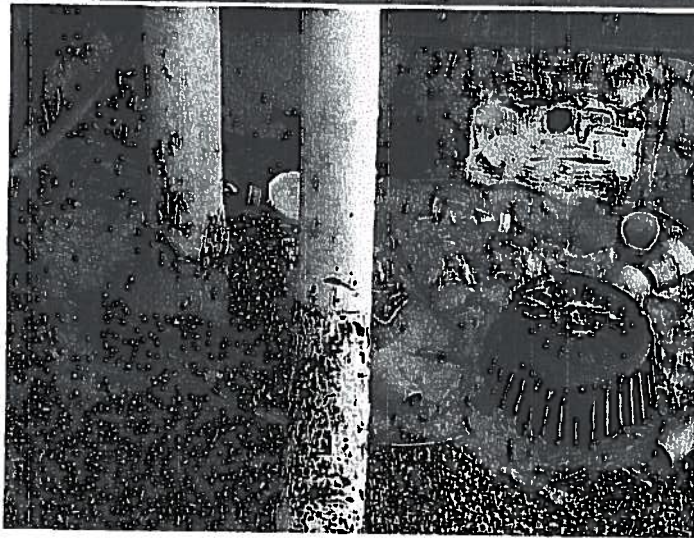
Debris on this roof section is collecting at the drains. The debris needs to be removed from the roof section to avoid clogging the drain during the next rain.
