Wetland Delineation

Figure 1

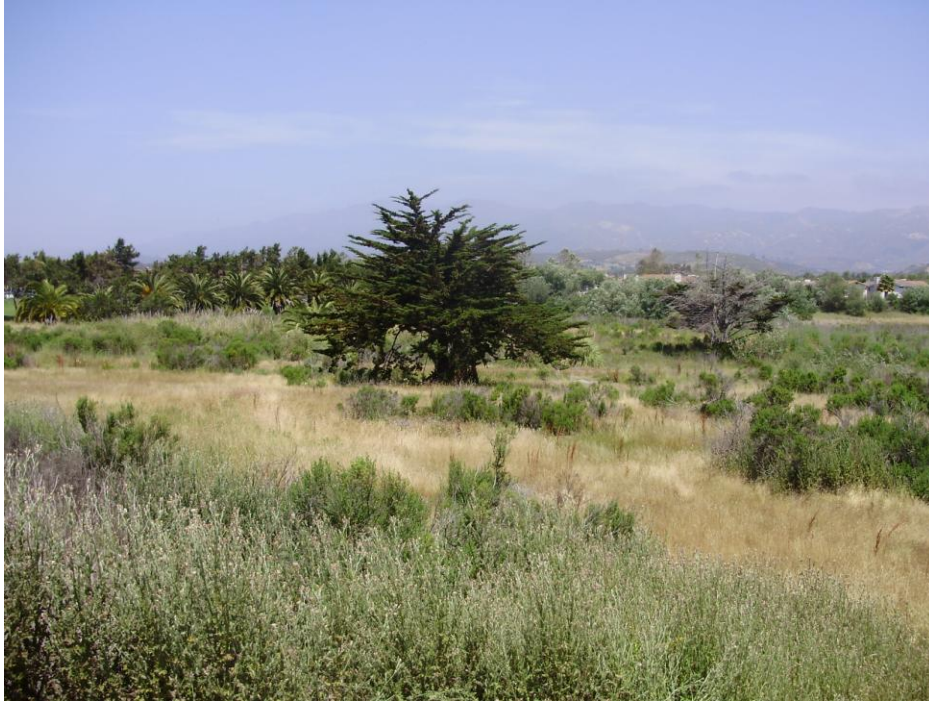
Photograph 1. View north of the study area from El Colegio Road. Vegetation within the site is comprised of a mix of non-native species as well as native wetland and upland plants.

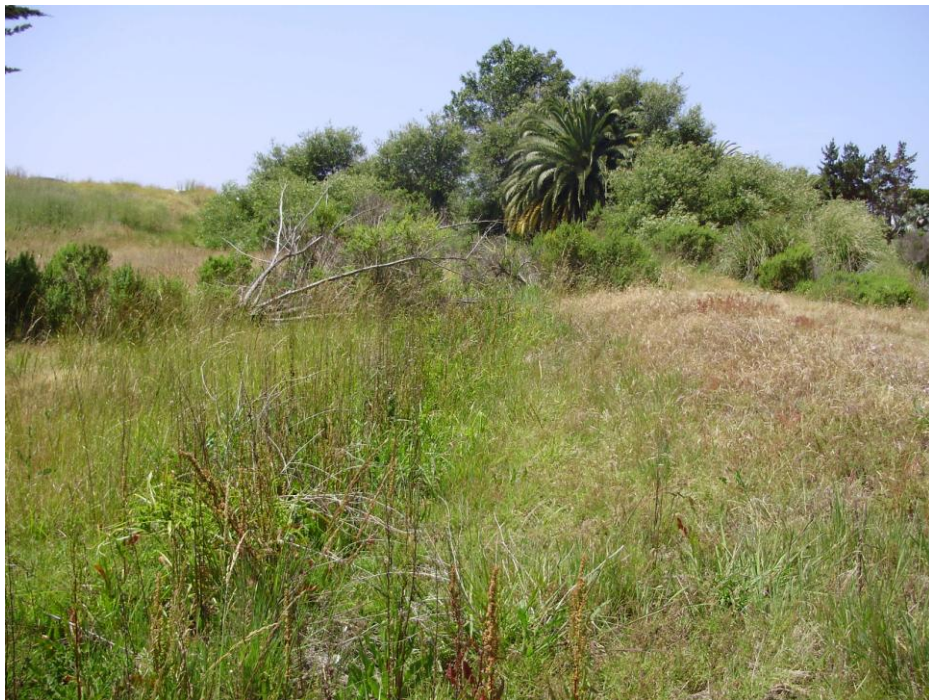
Photograph 2. View southwest of the swale constructed to accommodate flows from the culvert under El Colegio Road. Note the hydrophytic vegetation in the foreground and stand of willows in the background.

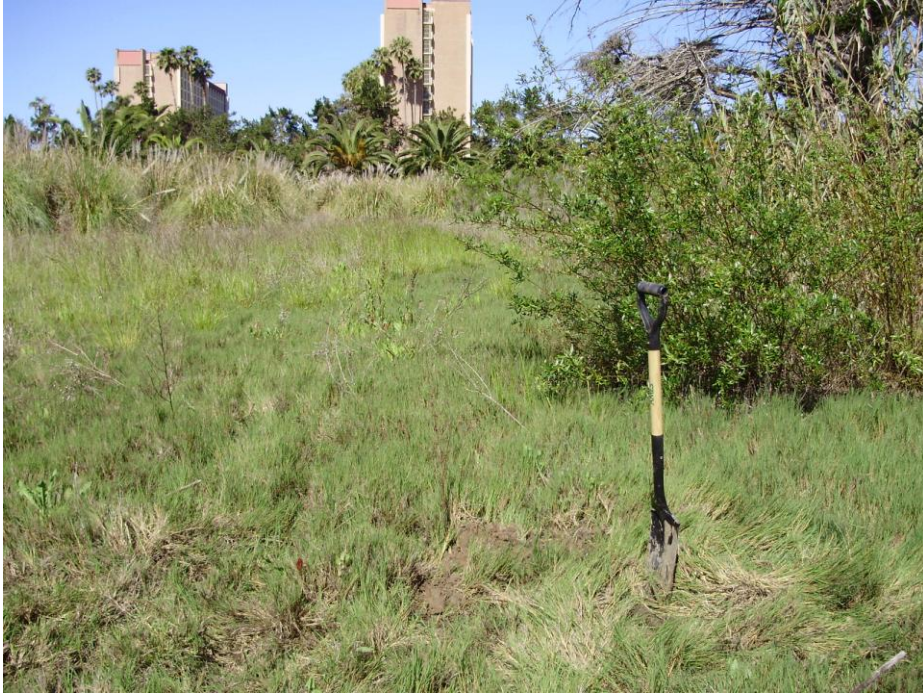
Photograph 3. View west of Sample Point 3. This area receives flows from two swale systems. Note the dense cover of *Distichlis spicata*.

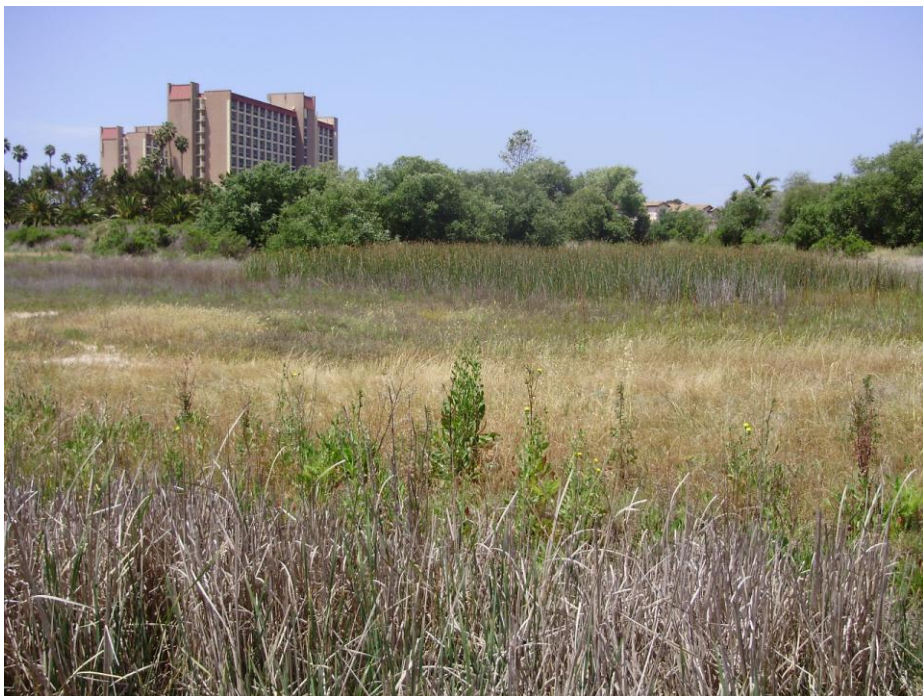
Photograph 4. View west from the culvert located in the northeast portion of the parcel. *Typha latifolia* associated with the drainage can be seen in the foreground, with the depressional wetland dominated by *Scirpus* spp. and associated willow stands in the background.
