Campus Point Stair Access Way
Project No. FM110220S/987767

Addendum No. 3

Campus Point Stair Access Way

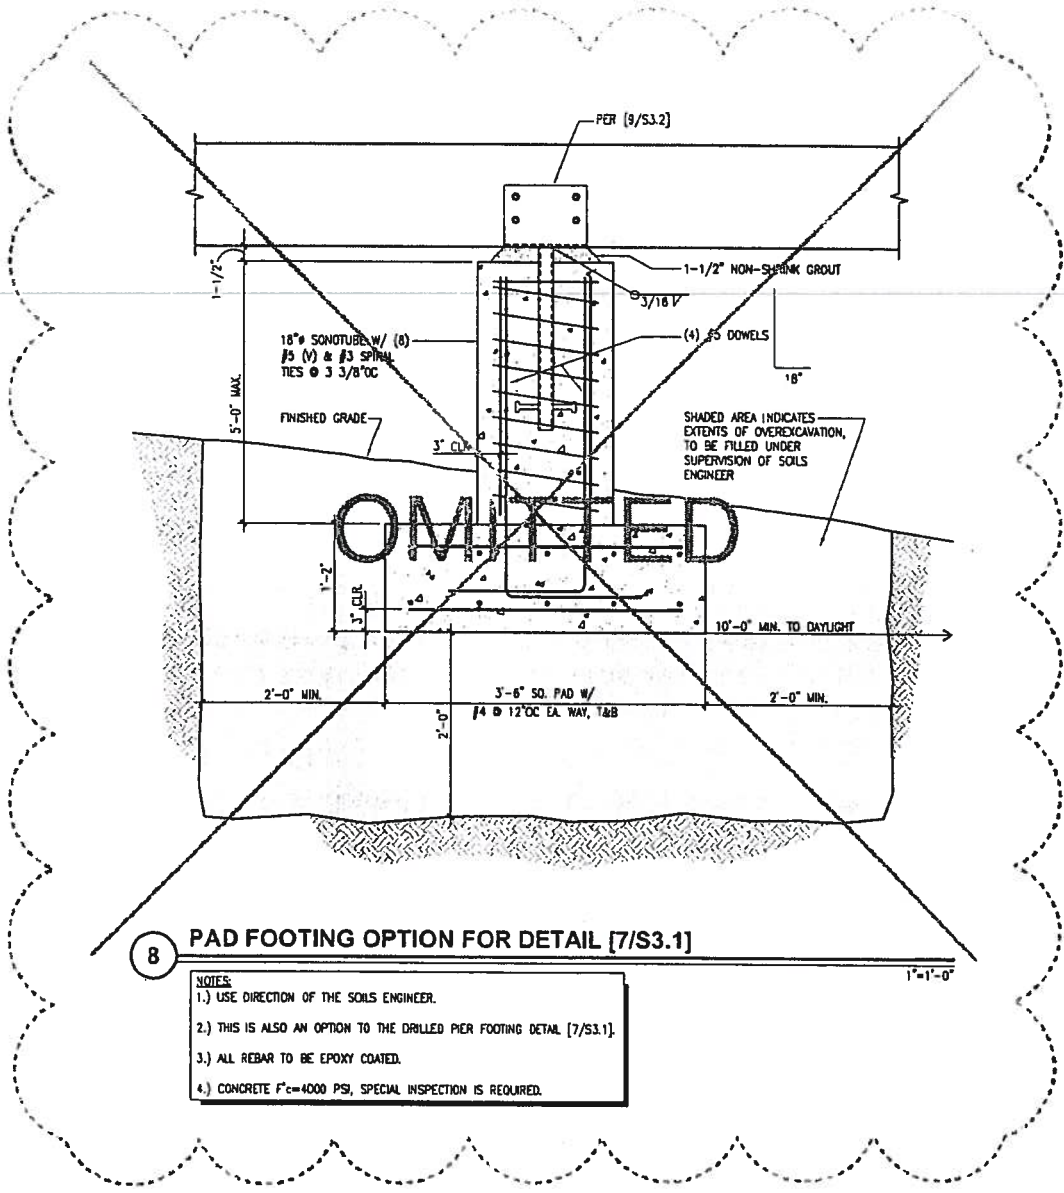
SK-L02

8 PAD FOOTING OPTION FOR DETAIL [7/S3.1]

- NOTES:**
- 1.) USE DIRECTION OF THE SOILS ENGINEER.
 - 2.) THIS IS ALSO AN OPTION TO THE DRILLED PIER FOOTING DETAIL [7/S3.1].
 - 3.) ALL REBAR TO BE EPOXY COATED.
 - 4.) CONCRETE $F_c=4000$ PSI, SPECIAL INSPECTION IS REQUIRED.

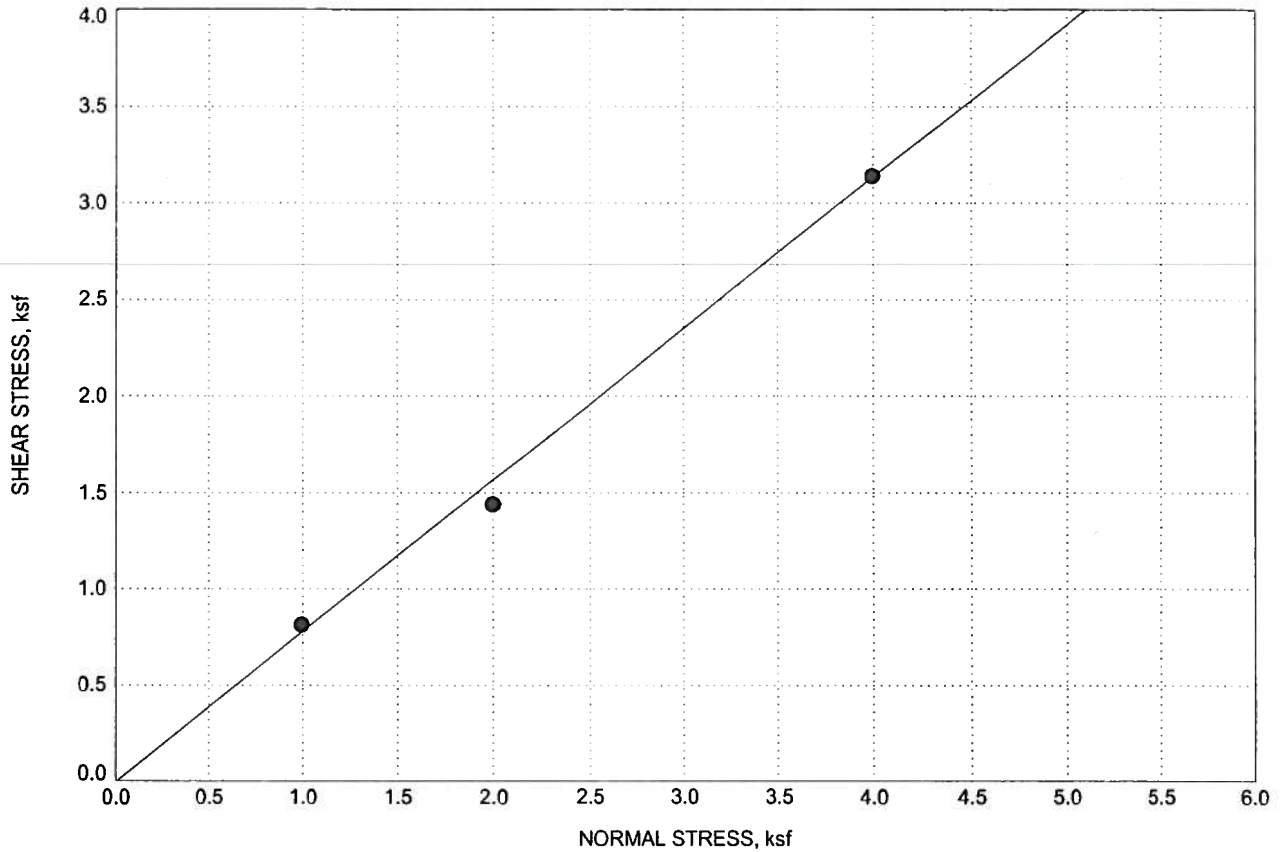
DIRECT SHEAR TEST RESULTS
 UCSB Lagoon Restoration - Bluff Access Stairway
 Santa Barbara, California

COHESION, ksf	0.0
ANGLE OF INTERNAL FRICTION, deg	39
LOCATION	S-5
DEPTH, ft	28
MOISTURE CONTENT, %	9
UNIT DRY WEIGHT, pcf	90
MATERIAL DESCRIPTION	Silty SAND (SM)
SAMPLE CONDITION	Ring Sample
