**PRELIMINARY  
GEOTECHNICAL REPORT**  
Francisco Torres Apartments  
El Colegio at Storke Road  
Isla Vista, California

Subject: Preliminary Geotechnical Report, Francisco Torres Apartments, El Colegio at Storke Road, Isla Vista, California

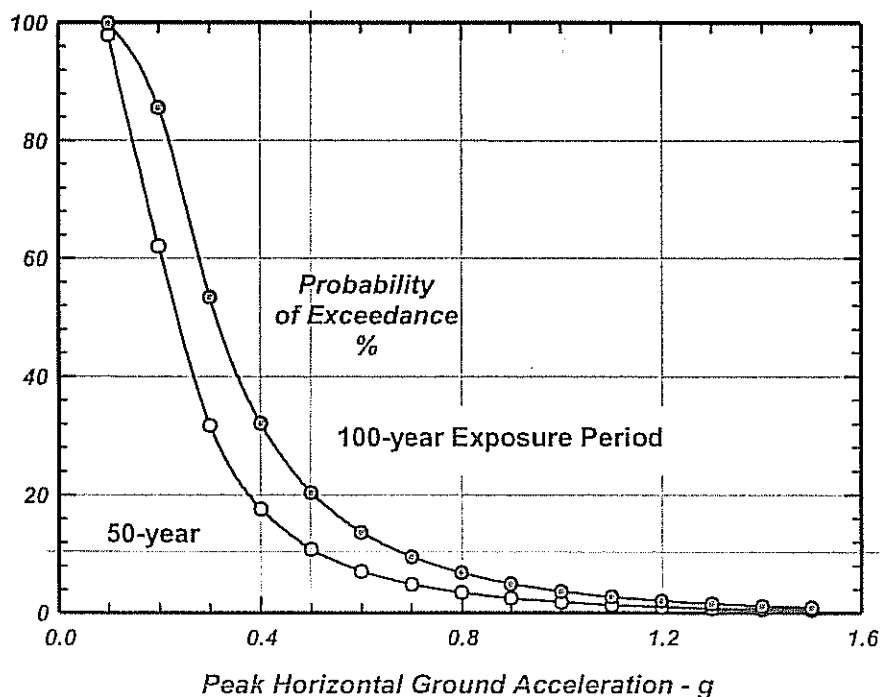
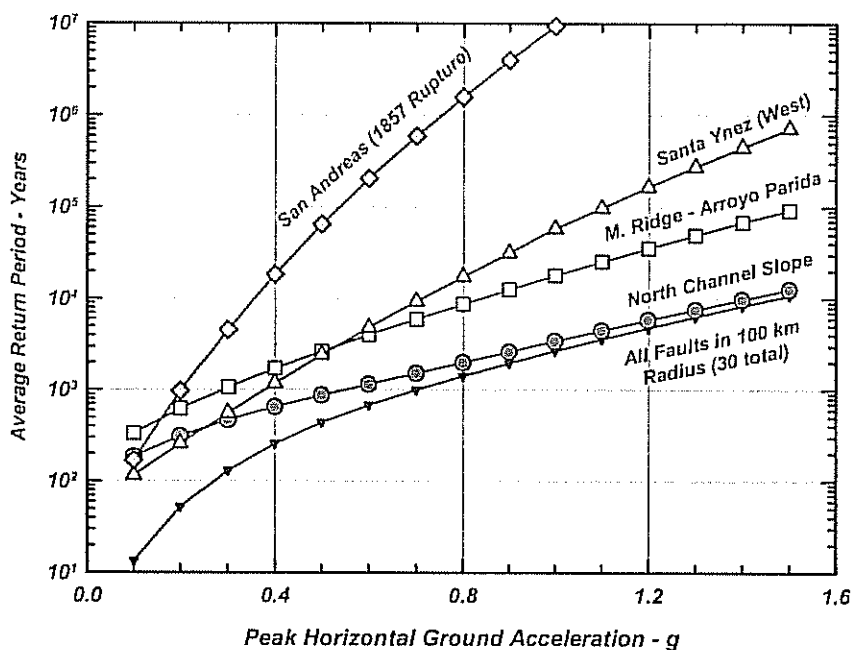
The results of the probabilistic analyses are also plotted on the accompanying figures. The first plot presents the probability of exceedance versus peak horizontal ground acceleration for exposure periods of 50 and 100 years considering all 30 fault sources. The second plot that follows shows the average return period versus peak horizontal ground acceleration assuming all 30 faults sources, and the results for selected individual fault sources within 100 kilometers of the site. Either plot can be used to estimate the peak horizontal ground accelerations included in the above table.

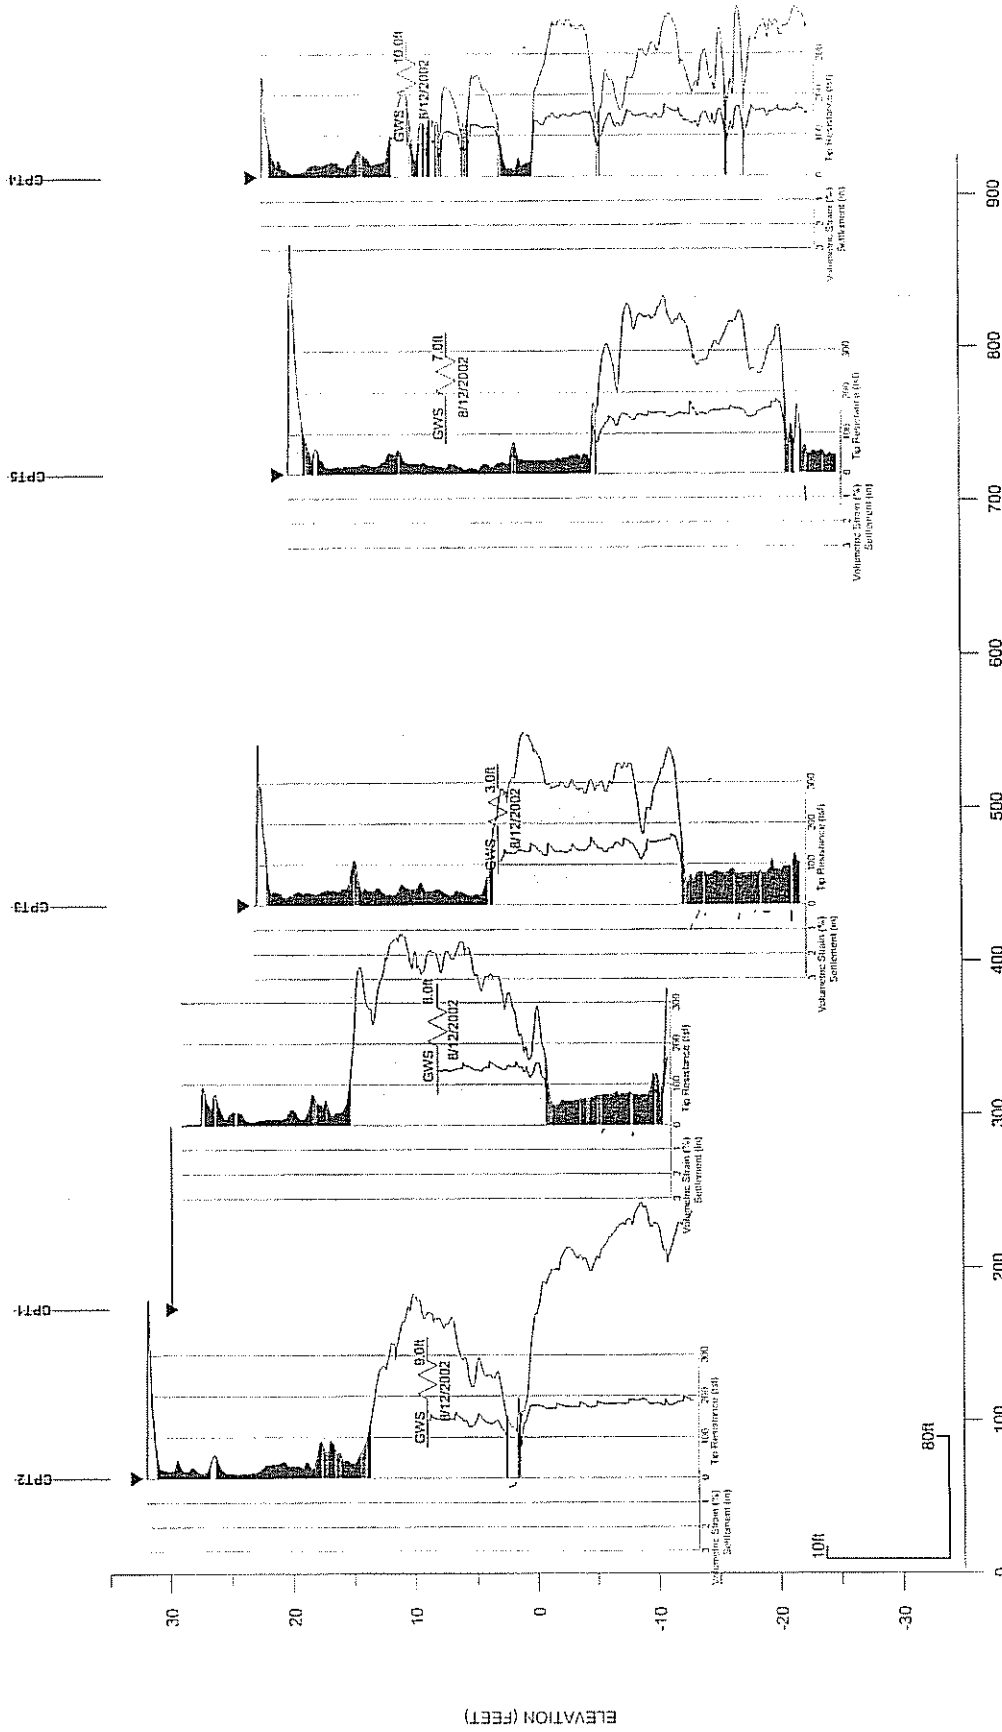
SUBSURFACE CROSS SECTION  
WITH LIQUEFACTION EVALUATION  
Magnitude = 7.1, Acceleration = 0.52 g  
Francisco Torres Apartments  
Isla Vista, California

Liquefaction is the loss of soil strength due to an increase in soil pore water pressures that results from seismic ground shaking. Three general geotechnical conditions should be present for liquefaction to occur: 1) groundwater is present within the potentially liquefiable material; 2) the soil is granular and meets a specific range of grain sizes; and 3) the soil is in a loose state of low relative density. If those conditions are present and strong ground motion occurs, portions of the soil column could liquefy, depending upon the intensity and duration of the strong ground motion.
